Home Inspection Report

3113 Humboldt Ave South, Minneapolis, MN 55420

Monday December 3, 2018

MSP Inspections LLC
4304 Sumac Point
Eagan, MN 55122
(612)8162363
yslutsky@gmail.com

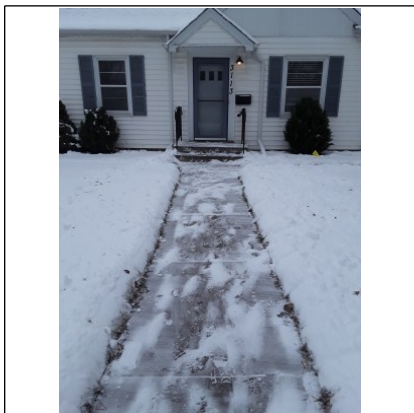
Comments Walkway had some cracking, but is usable.

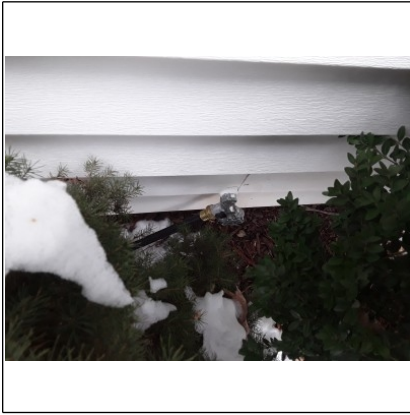
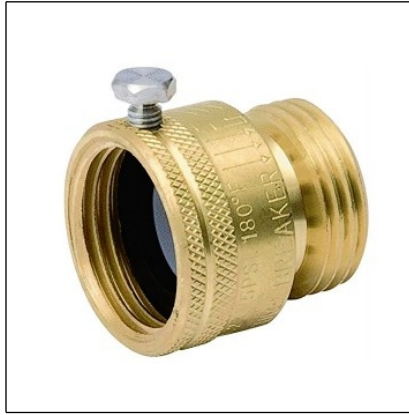
Comments Hose bib(s) not equipped with anti-siphon devices, possible cross connection can occur with anti-siphon device, recommend installing

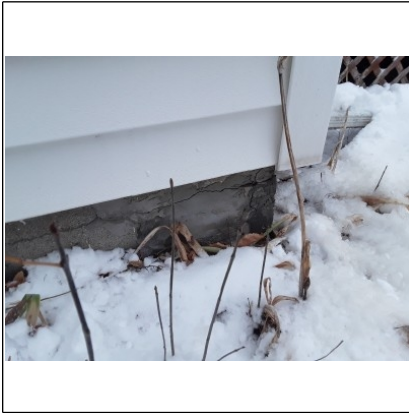
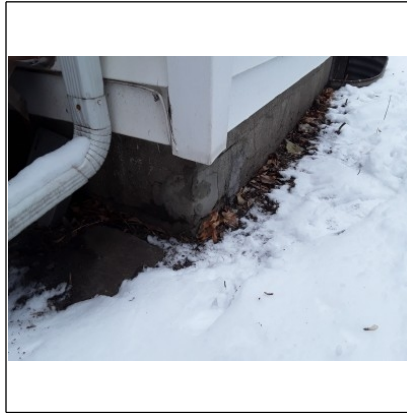
Comments Foundation (stem) wall contains cracks. Recommend repair and monitor.

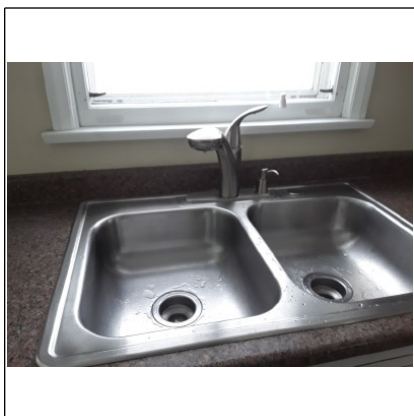
Comments There were no visible active piping leaks at the time of the inspection.

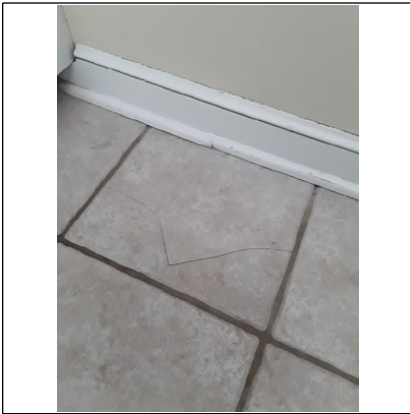
Comments Cracked tiles
Floor covering is damaged, trip hazard. Recommend repair/replace

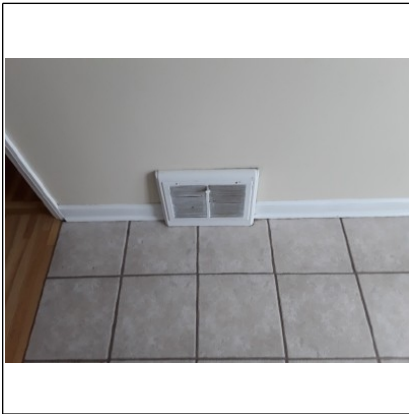
Comments Needs to be painted

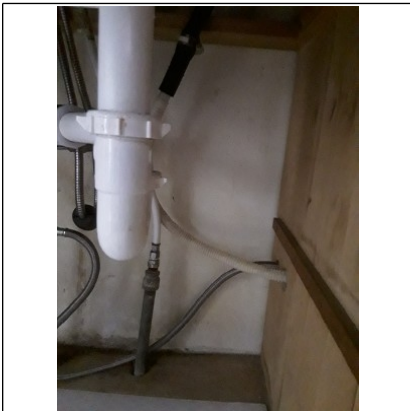
- Disposal** N/A Not tested Operable: Yes No Recommend repair
 Exposed wires under the sink recommend repair
 Romex wiring, recommend replacing with armored cable or plug
- Oven** N/A Not tested Operable: Yes No Recommend repair
 For enhanced safety recommend installing anti-tip bracket
- Range** N/A Not tested Operable: Yes No Recommend repair
 Burner(s) not working recommend repair
- Dishwasher** N/A Not tested Operable: Yes No Recommend repair Leaking recommend repair
- Exhaust fan** N/A Not tested Operable: Yes No Recommend repair
 Filters dirty recommend replacing
- Refrigerator** N/A Not tested Operable: Yes No Recommend repair
- Microwave** N/A Not tested Operable: Yes No
- Dishwasher airgap** Yes No N/A
- Dishwasher drain line looped** Yes No Not visible Recommend Looping Drain Line N/A
- Comments** Dishwasher drain line not looped beneath countertop. Recommend repair

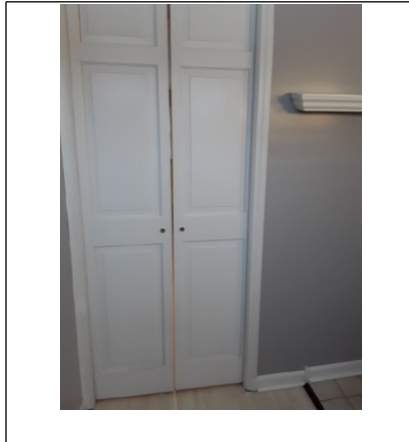
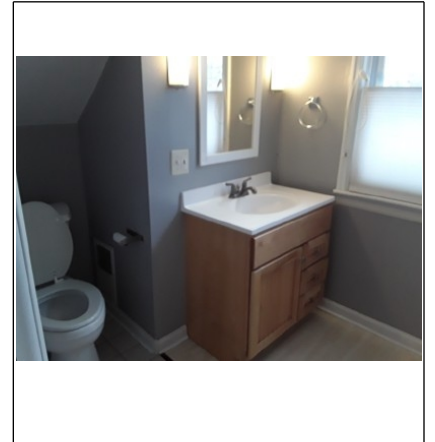
Need some repair

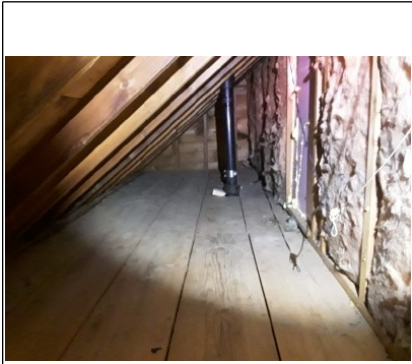
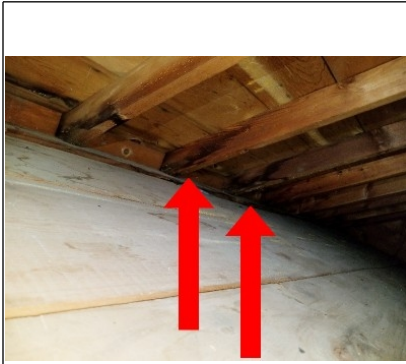
There is no ventilation on the accessible side of the attic. Recommend roofing contractor for evaluation and repair.
Main panel does not appear grounded.

Moisture stains. There are no ventilarion on this side of attic.

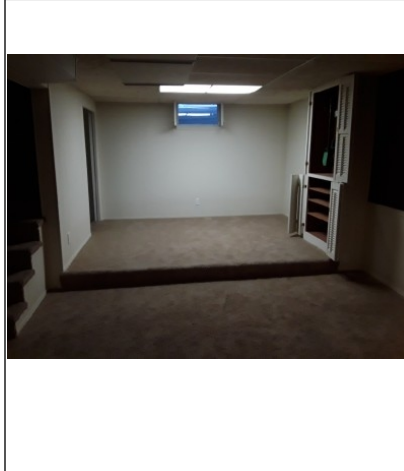
Need to install another railing, safety concern.

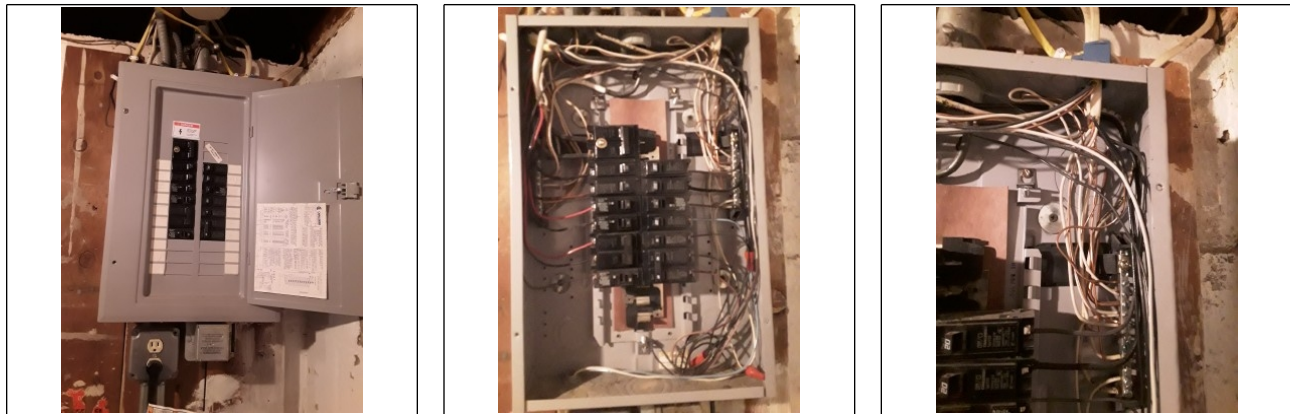
Comments Main panel does not appear grounded.

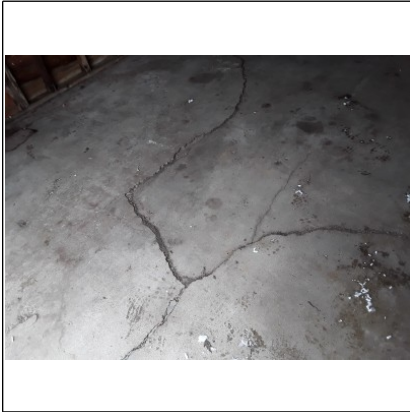
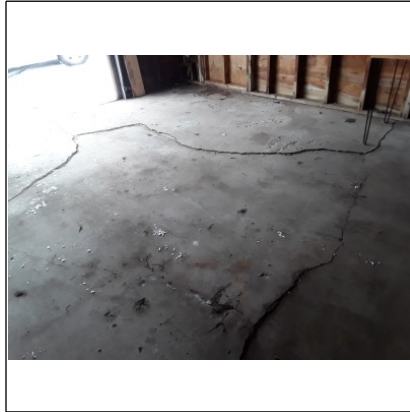
- Material** Concrete Gravel Asphalt Dirt Other: .
- Condition** Satisfactory Typical cracks Large settling cracks Safety hazard
- Recommendation** Recommend repair Monitor N/A
- Comments** The foundation had some cracking , recommend monitoring
