Home Inspection Report

3113 Humboldt Ave South, Minneapolis, MN 55420

Monday December 3, 2018

MSP Inspections LLC
4304 Sumac Point
Eagan, MN 55122
(612)8162363
yslutsky@gmail.com

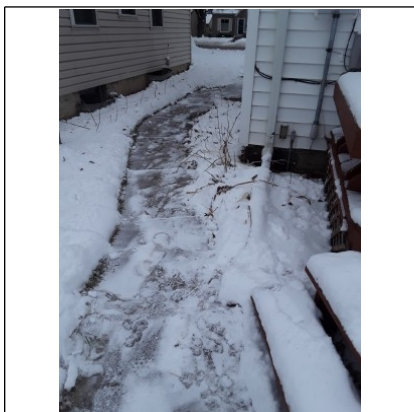
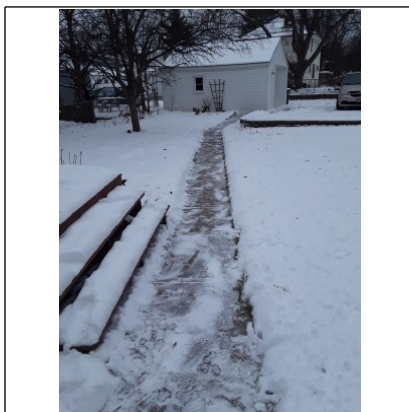
Condition Satisfactory Marginal Poor Trip hazard Typical cracks Pitched towards home
 Settling cracks Public sidewalk needs repair Settled

Recommendation Repair As Needed Monitor Mudjack N/A Monitor

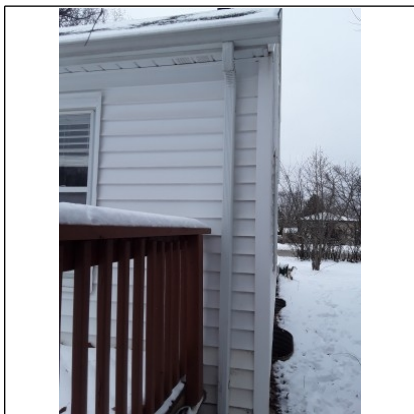
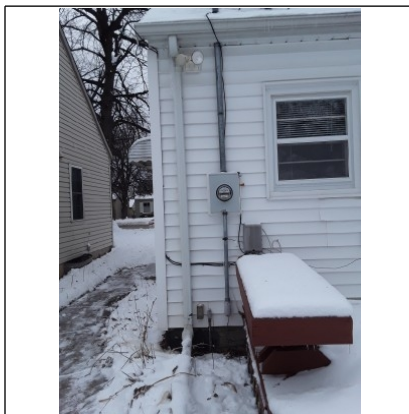
Condition Satisfactory Marginal Poor Rusting Damaged Loose or damaged sections

Leaking Corners Joints Hole in main run No apparent leaks
 Could not determine if gutters were leaking during inspection
 Minor maintenance of sealing joints in gutters to prevent leaking

Recommendation Properly Slope Gutters Add Additional Downspouts Repair As Needed Clean Gutters
 N/A Extend Downspout extensions 5-6' or more away from home
 Repair straps on downspouts Recommend adding gutters
 Drip edge flashing improperly installed, repair Repair/Replace any damaged sections

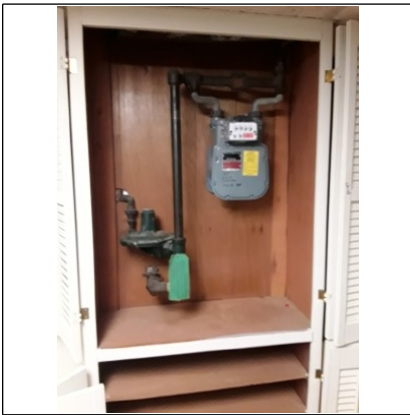
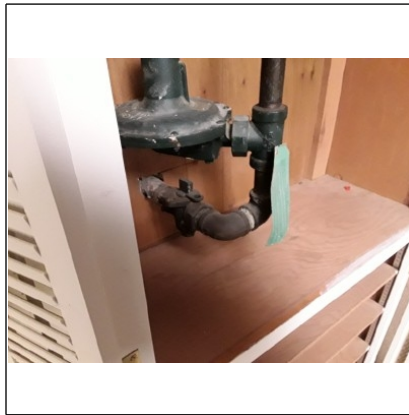
Main Fuel Shutoff

Location Front Of Home Side Of Home Back Of Home Basement Rusted
 Recommend painting
Comments:

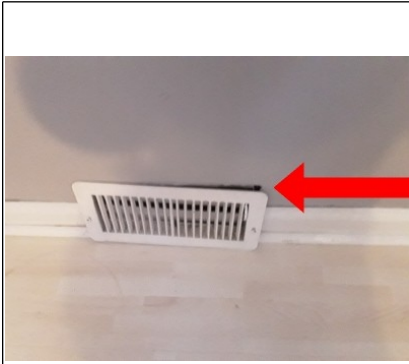
Bathroom (2)

Need some repair

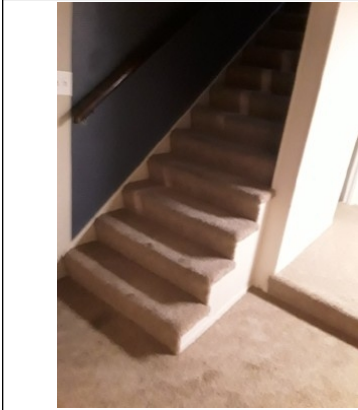
Need to install another railing, safety concern.
